This guide will step you through troubleshooting the GPS receiver via NavCom's StarUtil GUI program.

Problem - GPS Receiver's LEDs all illuminate, but can not communicate with one or more ports.

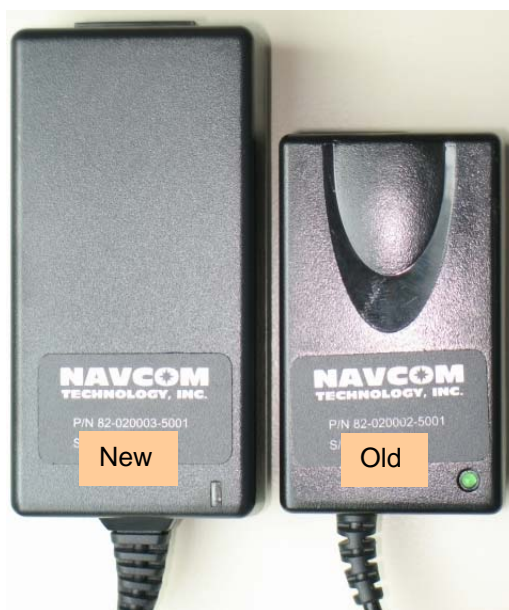
- ✓ The three possible causes for this condition:
 - Power supply
 - Software corruption
 - Hardware malfunction
 - Failed MMC card
 - Failed IOP card
 - Failed IOP oscillator
 - Failed GPS engine
- ✓ Power supply
 - Some of the older model power supplies are known to provide the correct voltage, but insufficient current. If the older model power supply is in use (see picture below), please contact NavCom Tech Support for a replacement unit.
<http://www.navcomtech.com/Contact/ContactSupport.cfm>

- If the unit is powered via a variable power supply or a power supply not provided by NavCom, verify the power supply is providing the same or better power as the module provided by NavCom.
 - Power requirements are 10 to 30VDC, 2 amps
- If the model in use is operating on a battery supply
 - Ensure the battery is fully charged
 - Exchange battery with a known good battery
 - Replace the battery pack
