This guide will step you through loading IOP software to the GPS receiver via NavCom’s StarUtil GUI program.

Problem - GPS Receiver’s IOP software is corrupt

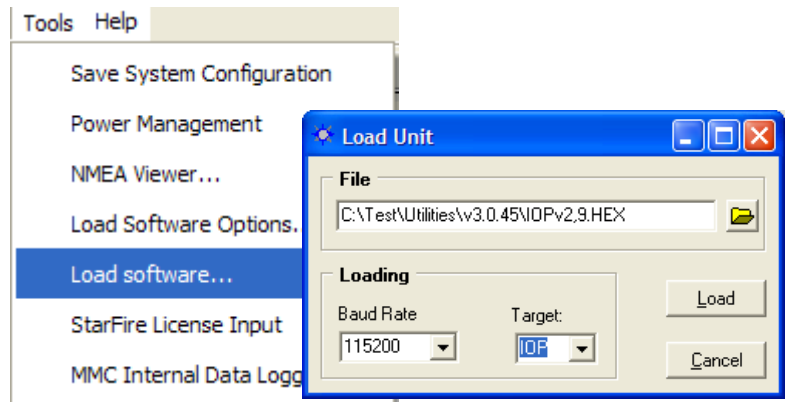
- ✓ *Tools* →
- ✓ *Load Software...* →
- ✓ Load Unit - Select the 'IOPv#,#.HEX' file (click to browse file if necessary), where # is software version number
- ✓ Set the Baud Rate to 19200
- ✓ Set Target: *IOP*.
- ✓ Click Load to initiate software upload.
- ✓ Turn ON the GPS receiver and IOP software will upload.

Make sure to start the load within 3 seconds of turning the receiver on. The boot program looks at the com port during the first 3 seconds at 19200 before executing the primary program. This provides a single opportunity to regain control of the receiver and load the software. After the 3 second interval, the receiver state or port baud rate is unknown, particularly if it was set to some other value.
