This guide will step you through loading navigation software to the GPS receiver via NavCom's StarUtil GUI program.

Problem - GPS Receiver's Navigation software is corrupt

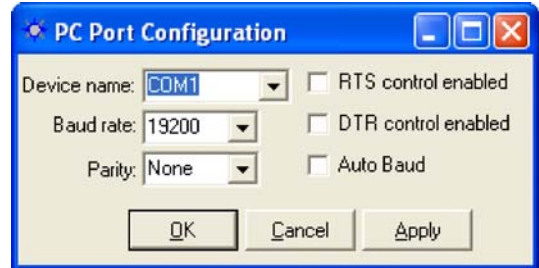
- ✓ Run StarUtil, click on

icon to open up the PC Port Configuration dialog.

- ✓ Select
 - Device name: PC COM port
 - Baud rate: 19200
 - Parity: None
 - uncheck Auto Baud
 - click OK.

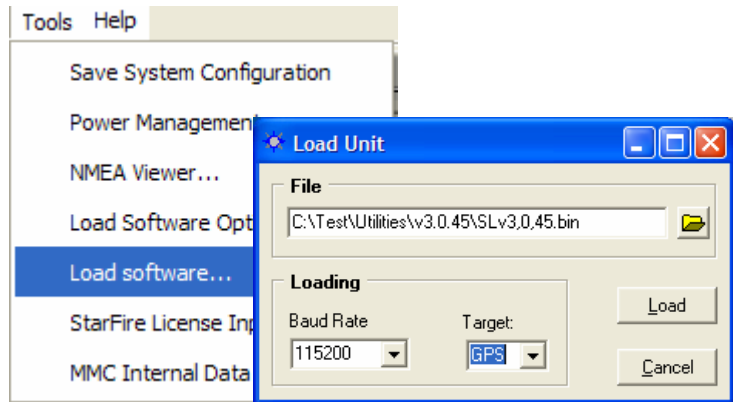
- ✓ Tools →
- ✓ Load Software...→
- ✓ Load Unit - Select the 'SLv#,#,##.bin' file (click to browse file if necessary), where # is software version number
- ✓ Set the Baud Rate to 115200
- ✓ Set Target: GPS.
- ✓ Click Load to initiate software upload.

- ✓ Turn ON the GPS receiver and Navigation (GPS) software will upload.
